ANALYSIS AND MODEL TESTING OF A DUAL ORIGIN NATURAL GAS FIRE WITH REMOTE FUEL SOURCE AND REMOTE PILOTED IGNITION MECHANISM

ABSTRACT

FIRE INCIDENT BACKGROUND

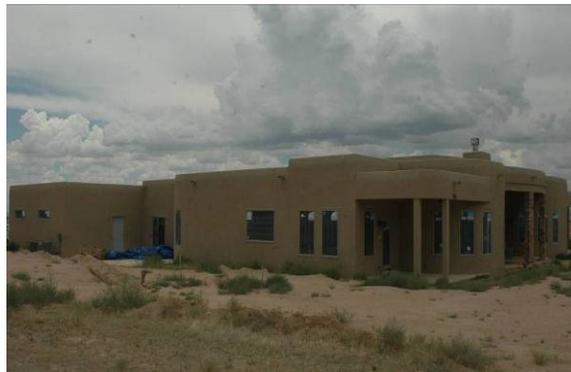
Figure 1 – The incident residence after the fire.

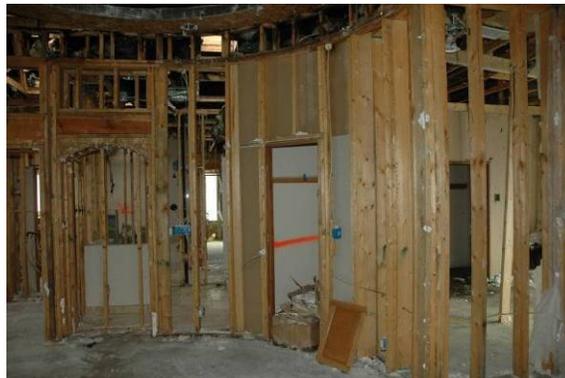
The walls of the residence were framed using 2 x 6 lumber, with 1/2-inch sheetrock on the walls and ceilings. The sheetrock was in place during the fire, but most of it had been removed prior to the investigation (Figure 2).

Figure 2 –The residence interior after the fire and after the sheetrock had been removed.

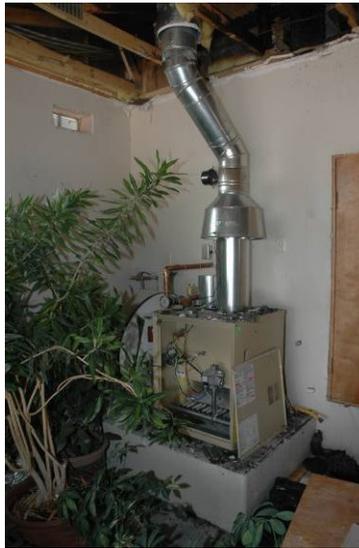
It was of particular interest that the ceiling height in the living areas of the home was approximately 18 inches higher than the ceiling height in the garage. This meant that the natural gas lines, which were routed just above the ceiling in the garage, entered into the end of a wall which was perpendicular to the garage wall, then progressed into the blown insulation wall cavity of the perpendicular wall, prior to turning downward for connections to the water heater, furnace and the boiler for floor heating. The gas line branch for the floor heating boiler turned downward at a T-fitting and proceeded to a location near the bottom of the blown insulation-filled cavity, where there was an elbow for connecting a short length of pipe that went horizontally back out of the cavity and into the garage. A 21-inch long length of pipe was screwed into this elbow and extended out through the garage wall where it was capped just outside the sheetrock at a location which was behind the boiler for the floor heating system (Figure 3).

Figure 3 – The floor heating system boiler in the garage of the residence. The capped gas line protruding from the wall and the nearby water heater and furnace closet can be seen behind the boiler.

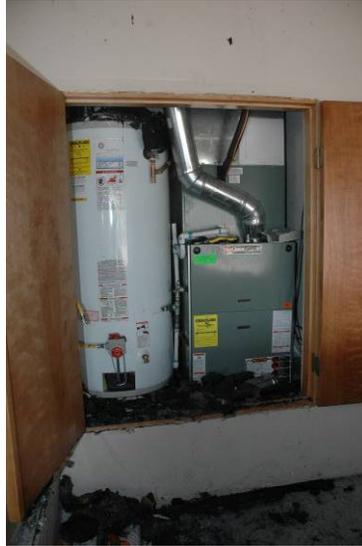
Approximately two feet to the right of the boiler in the garage was an elevated closet which housed the natural gas water heater and central heating furnace. Below the closet was a furnace air return duct having dimensions of approximately 2 feet high by 4 feet wide by 6 feet long. The air return duct was constructed from wood framing, and it had a plastic vent cover over the open end in the room adjacent to the garage, which was behind the boiler (Figure 4).

Figure 4 –The water heater and furnace closet. Note the lack of fire damage in the closet.

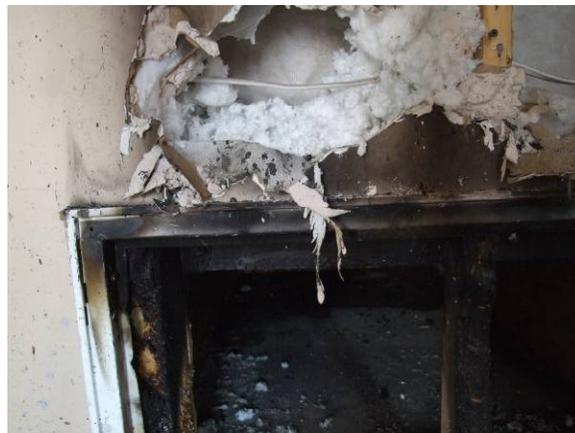
Investigation indicated that fire patterns around the plastic vent cover and the structural members behind the vent cover of the air return duct had characteristics of a potential fire origin at that location (Figure 5). Additional fire patterns at the location where the natural gas line entered at the top of the end of the perpendicular wall were also of the type characteristic of a fire origin (Figure 6). Part of the evidence associated with these burn patterns was a lack of contiguous fire damage or burning between these two locations. It was of interest that except for the air return grille and its backing structural members, the fire was confined essentially to the attic of the residence and above the ceiling. The fire in the attic extended nearly throughout the entire attic and caused substantial damage to the residence. The greatest burn damage and char was located around and above the apparent second origin location where the natural gas line entered the top of the perpendicular wall.

Figure 5 – The burn pattern at the air return duct.

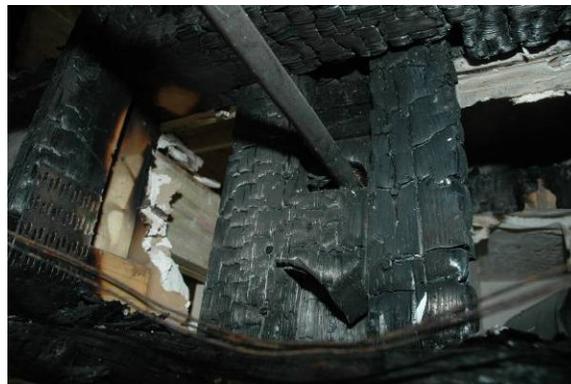
Figure 6 – The area where the gas line entered the end of the insulation-filled wall cavity.

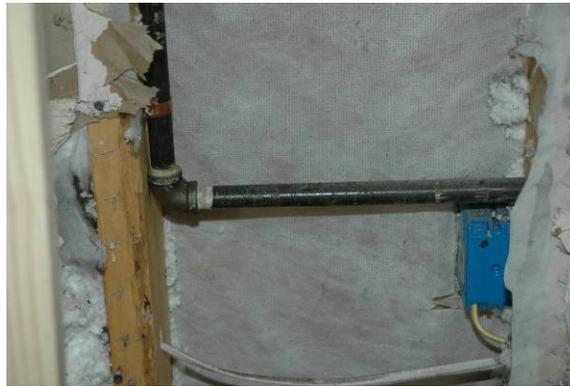
Analysis of the evidence and witness interviews in the case indicated that when a workman was attempting to hook up the natural gas to the boiler in the garage, he mistakenly decided to do so without turning off the natural gas to the residence. He then failed to properly hold onto the pipe when he attempted to take the cap off the end of the pipe that was protruding from the garage wall. This led to the unscrewing of the 21-inch section of pipe from the elbow connection in the wall and removing it from the wall. At that point, natural gas began flowing into the blown insulation-filled structural cavity. The nominal dimensions of the cavity were 6 inches wide, 18 inches long and 8 feet high. In a short time, the leak filled the cavity with natural gas (Figures 7 and 8).

Figure 7 – The 21-inch pipe installed as it would have been prior to removal by the workman.

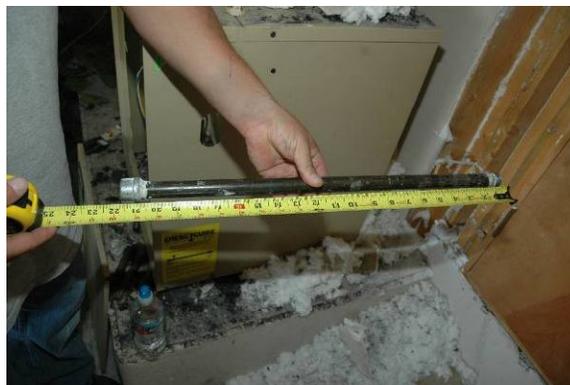
Figure 8 – The 21-inch long section of gas pipe which was removed from the wall cavity by the workman on the day of the fire.

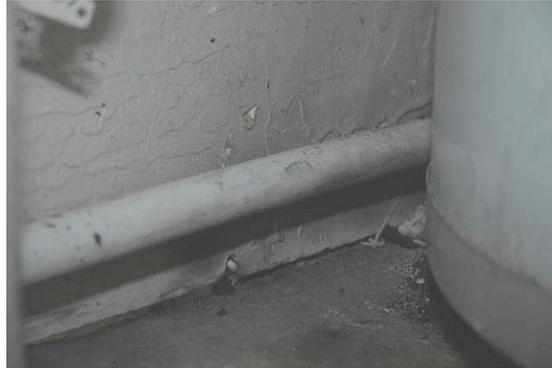
The natural gas exiting at the bottom of the insulation-filled cavity was then able to proceed along the upper surface of the air return duct and back toward the water heater and furnace closet. At the near edge of the closet, it found a 3/8-inch gap above the closet floor board through which it could enter the closet (Figure 9). Once in the closet, the gas was able to rise up in the closet and pass through a hole in the ceiling around the water heater vent stack to the attic and to move into

Figure 9 – The 3/8-inch gap above the floor board of the water heater and furnace closet where the natural gas entered the closet on the day of the fire.

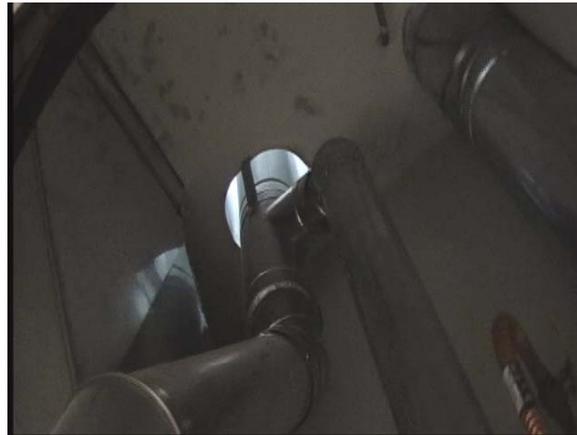
the closet until it encountered the pilot light of the water heater, where the pilot ignited the gas (Figure 10).

Figure 10 – A similar water heater vent stack that was located in another part of the residence.

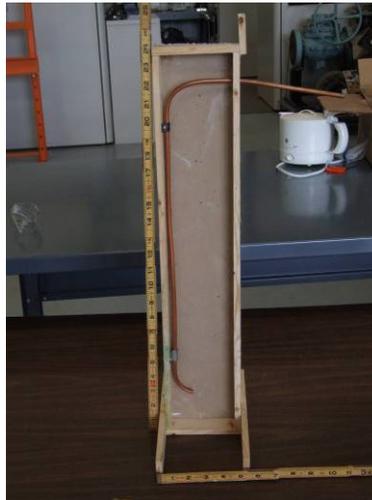
The one-quarter scale model is shown in Figure 11 prior to filling the model with the insulation. The copper tubing in the quarter scale model was proportionately sized to provide equivalent gas flow for the volume for the reduced size of the model. The insulation used in the tests was loose-fill fiberglass insulation, with the brand name *Attic Guard Premium*, which was the type that had been used in the residence where the fire occurred. Figures 12 and 13 show the quarter-scale model during testing. Note the near side of the model is covered with clear plexiglass. Also note that no burning occurred inside the insulation-filled cavity, even though the cavity was filled with natural gas.

Figure 11 – The one-quarter scale fire model prior to adding insulation.

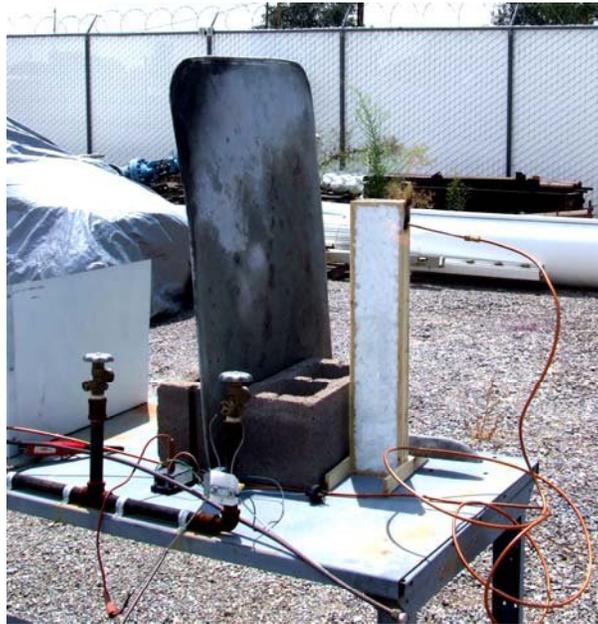
Figure 12 – The one-quarter scale fire model during testing.

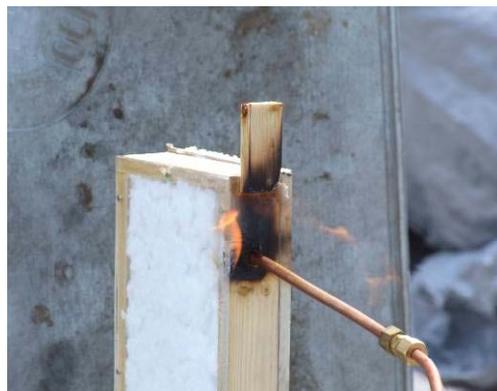
Figure 13 – The one-quarter scale fire model during testing.

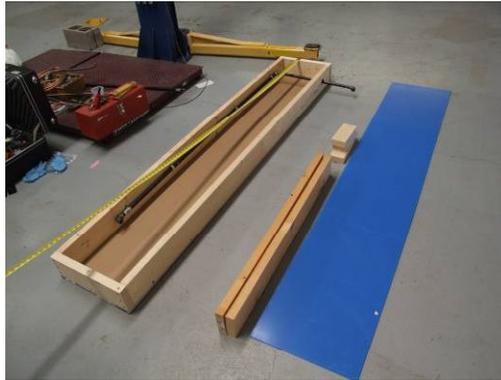
Figures 14, 15 and 16 show views of the full-scale model under construction. Note the enlarged drill hole around the inlet pipe shown in Figure 15. Also note the elbow fitting shown in Figure 16. This elbow represents the location where the 21-inch pipe had been unscrewed by the workman, which allowed the natural gas to escape inside the wall cavity.

Figure 14 – The full-scale fire model during construction.

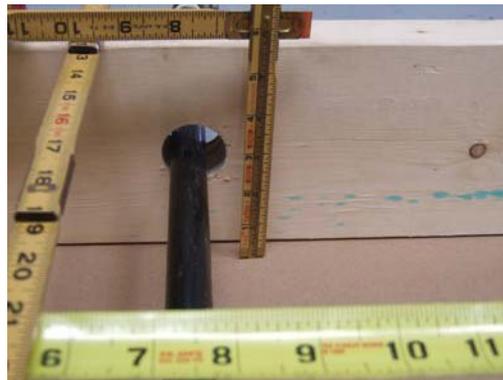
Figure 15 – The enlarged hole where the gas line entered the full-scale fire model wall cavity.

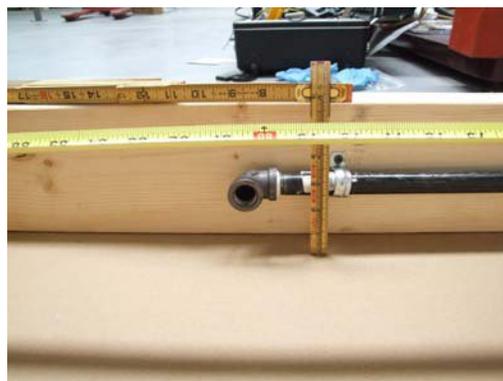
Figure 16 – The elbow near the bottom of the full-scale fire model where the gas escaped when the 21-inch pipe was unscrewed.

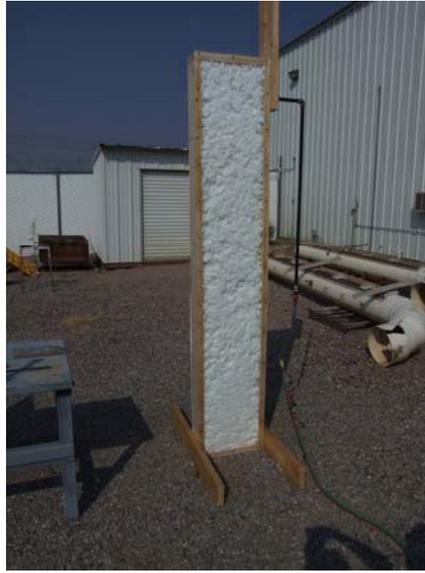
Figures 17 and 18 show the full-size model prior to testing. Note the enlarged hole seen in Figure 15 can also be seen in Figure 18.

Figure 17 – View showing the plexiglass-covered side of the full-scale fire model prior to testing.

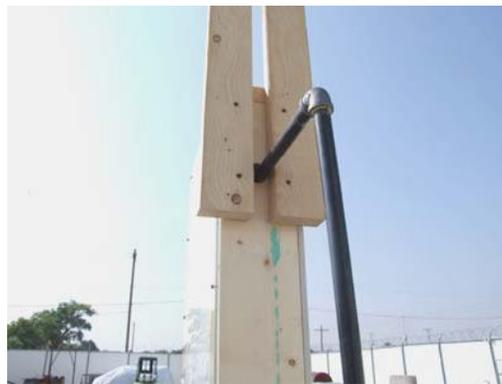
Figure 18 – The location near the top of the full-scale wall cavity where the gas line entered the cavity.

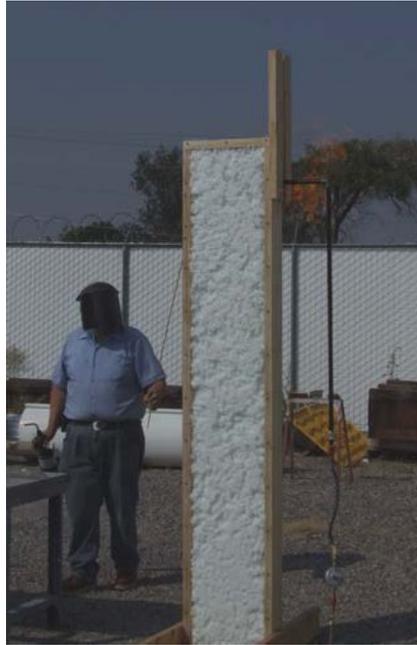
Figures 19 and 20 show the full-scale model during testing. Note the absence of burning inside the model in Figure 19, even though the insulation cavity is full of natural gas.

Figure 19 – The full-scale fire model during testing.

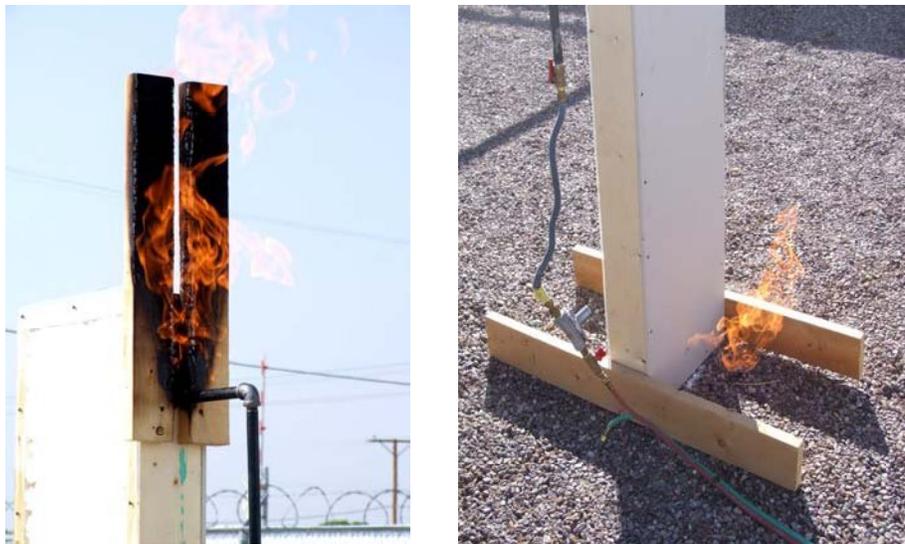
Figure 20 – The full-scale fire model during testing.

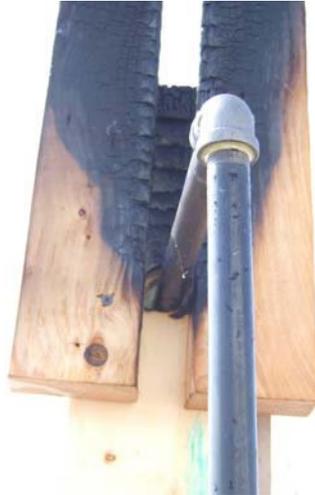
Figure 21 shows the area of the enlarged hole in the full-scale model after the fire test; note the similarity to the burn pattern shown in Figure 6.

Figure 21 – The fire pattern created at the top of the full-scale fire model after the burn testing.
